3843 GILPIN ST

## Property ID # 2305 / 3843 Gilpin Street

VASQUEZ BOULEVARD AND I-70

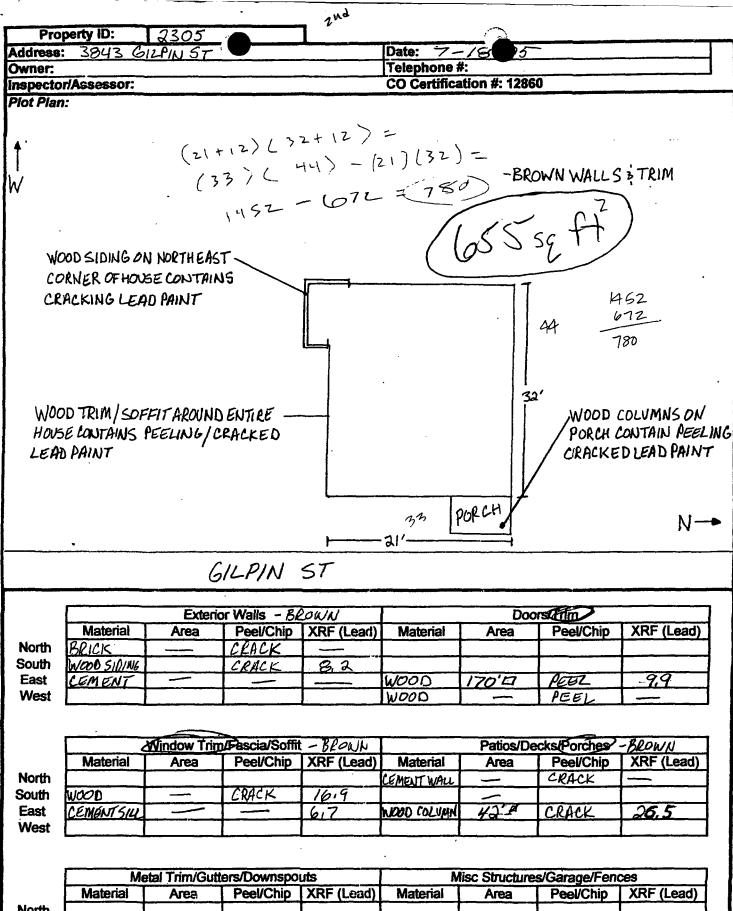
Site	Results	PbC	Floor	Room	Component	Substrate	Side	Condition	Color	
2305	Positive	26.5	FIRST	PORCH	COLUMN	WOOD	EAST	CRACKED	BROWN	0k
2305	Negative	0.17	FIRST	PORCH	EXT WALL	PLASTER	NORTH	CRACKED	BROWN	
2305	Negative	0.01	FIRST	OUTSIDE	EXT WALL	BRICK	NORTH	CRACKED	BROWN	7
£305	Positive	6.7	FIRST	OUTSIDE	EXT WALL	CONCRETE	EAST	Ç (₫D	BROWN	一、.
१ु95_	Positive	16.9	FIRST	OUTSIDE	WINDOW FRAME	WOOD	SOUTH	CRACKED	BROWN	
305	Positive	8.2	FIRST	PORCH	SIDING	WOOD	SOUTHING	CRACKED	BROWN	- P
2305	Negative	0.05	FIRST	OUTSIDE	FOUNDATION	PLASTER	WEST TO	CRACKED	BROWN	
2305	Negative	0.04	FIRST	PORCH	ROOF TRIM	WOOD	WEST	CRACKED	BROWN	一,,
2305	Positive	9.9	SECOND	PORCH	ROOF TRIM	WOOD	EAST	PEELING	- BROWN	W ->
			i <del> </del>							
						<u> </u>				
			<u> </u>					·

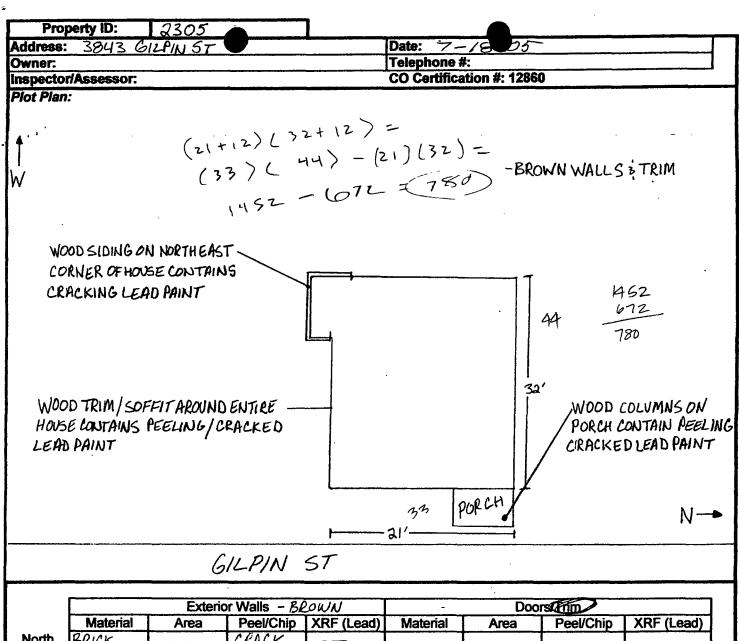
Exterior Walls - BLOWN					Doc	orstrim	
Material	Area	Peel/Chip	XRF (Lead)	Material	Area	Peel/Chip	XRF (Lead)
BRICK		CRACK					
W000 SIDING		CRACK	8,2				
CEMENT				WOOD	170'1	PEEL	-9,9
				WOOD		PEEL

Window Trim/Pascia/Soffit - BROWN				Patios/D	ecks/Porches	-BROWN	
Material	Area	Peel/Chip	XRF (Lead)	Material	Area	Peel/Chip	XRF (Lead)
				CEMENT WALL		CRACK	
WOOD		CRACK	16.9				
CEMBNISILL			617	MOOD COLVAN	42'F	CRACK	26.5
				I

Site	Results	PbC	Floor	Room	Component	Substrate	Side	Condition	Color
2305	Positive	26.5	FIRST	PORCH	COLUMN	WOOD	EAST	CRACKED	BROWN
2305	Negative	0.17	FIRST	PORCH	EXT WALL	PLASTER	NORTH	CRACKED	BROWN
2305	Negative	0.01	FIRST	OUTSIDE	EXT WALL	BRICK	NORTH	CRACKED	BROWN
2305	Positive	6.7	FIRST	OUTSIDE	EXT WALL	CONCRETE	EAST	CRACKED	BROWN
2305	Positive	16.9	FIRST	OUTSIDE	WINDOW FRAME	WOOD	SOUTH	CRACKED	BROWN
2305	Positive	8.2	FIRST	PORCH	SIDING	WOOD	SOUTH	CRACKED	BROWN
2305	Negative	0.05	FIRST	OUTSIDE	FOUNDATION	PLASTER	WEST	CRACKED	BROWN
2305	Negative	0.04	FIRST	PORCH	ROOF TRIM	WOOD	WEST	CRACKED	BROWN
2305	Positive	9.9	SECOND	PORCH	ROOF TRIM	WOOD	EAST	PEELING	BROWN
Note: 1	Readings are in n	ng/cm <sup>2.</sup>							
		<del>-</del>		_		<del> </del>			
Painted	surfaces not tes	ted were asses	sed to be in	'intact' condition	at time of site visit.
